# **Navajo Abandoned Uranium Mine**

## **Site Screen Report**

**Mine Name: Max Huskon No. 5**  
**Mine ID: 183**

**August 2011**

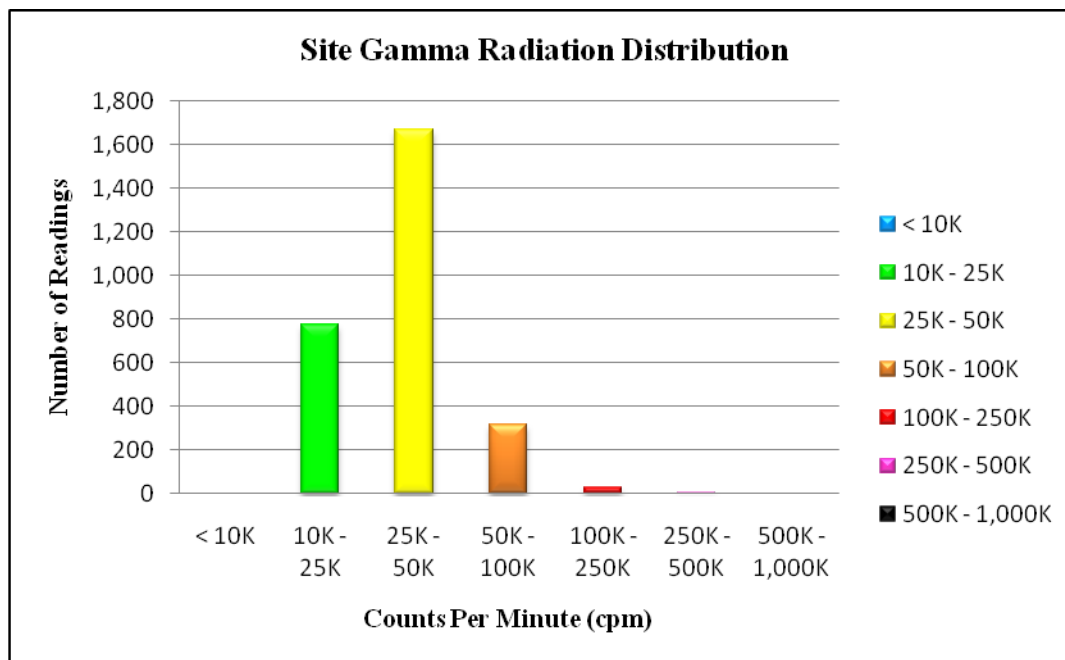
#### Site Gamma Radiation Statistics

Number of Readings	2,793
Minimum (cpm)	14,754
Maximum (cpm)	316,089
Mean (cpm)	35,011
Median (cpm)	30,080
Standard Deviation	20,400

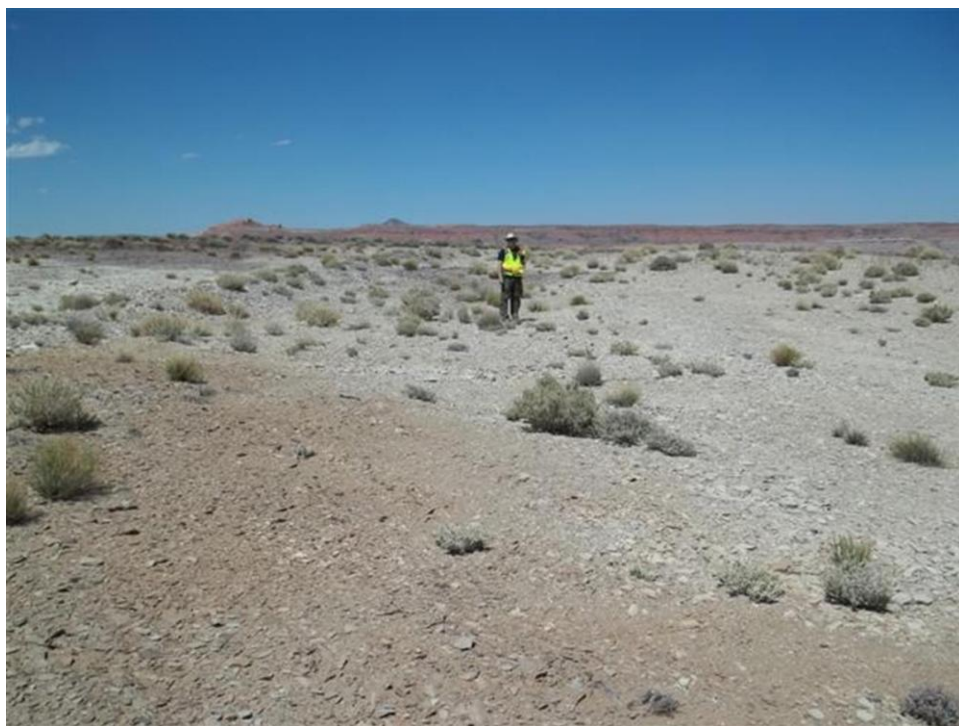
**Photo 5:** Mine Site #183; Berm area

Excavated area in center of site, 50 yds in diameter, surrounded by berms

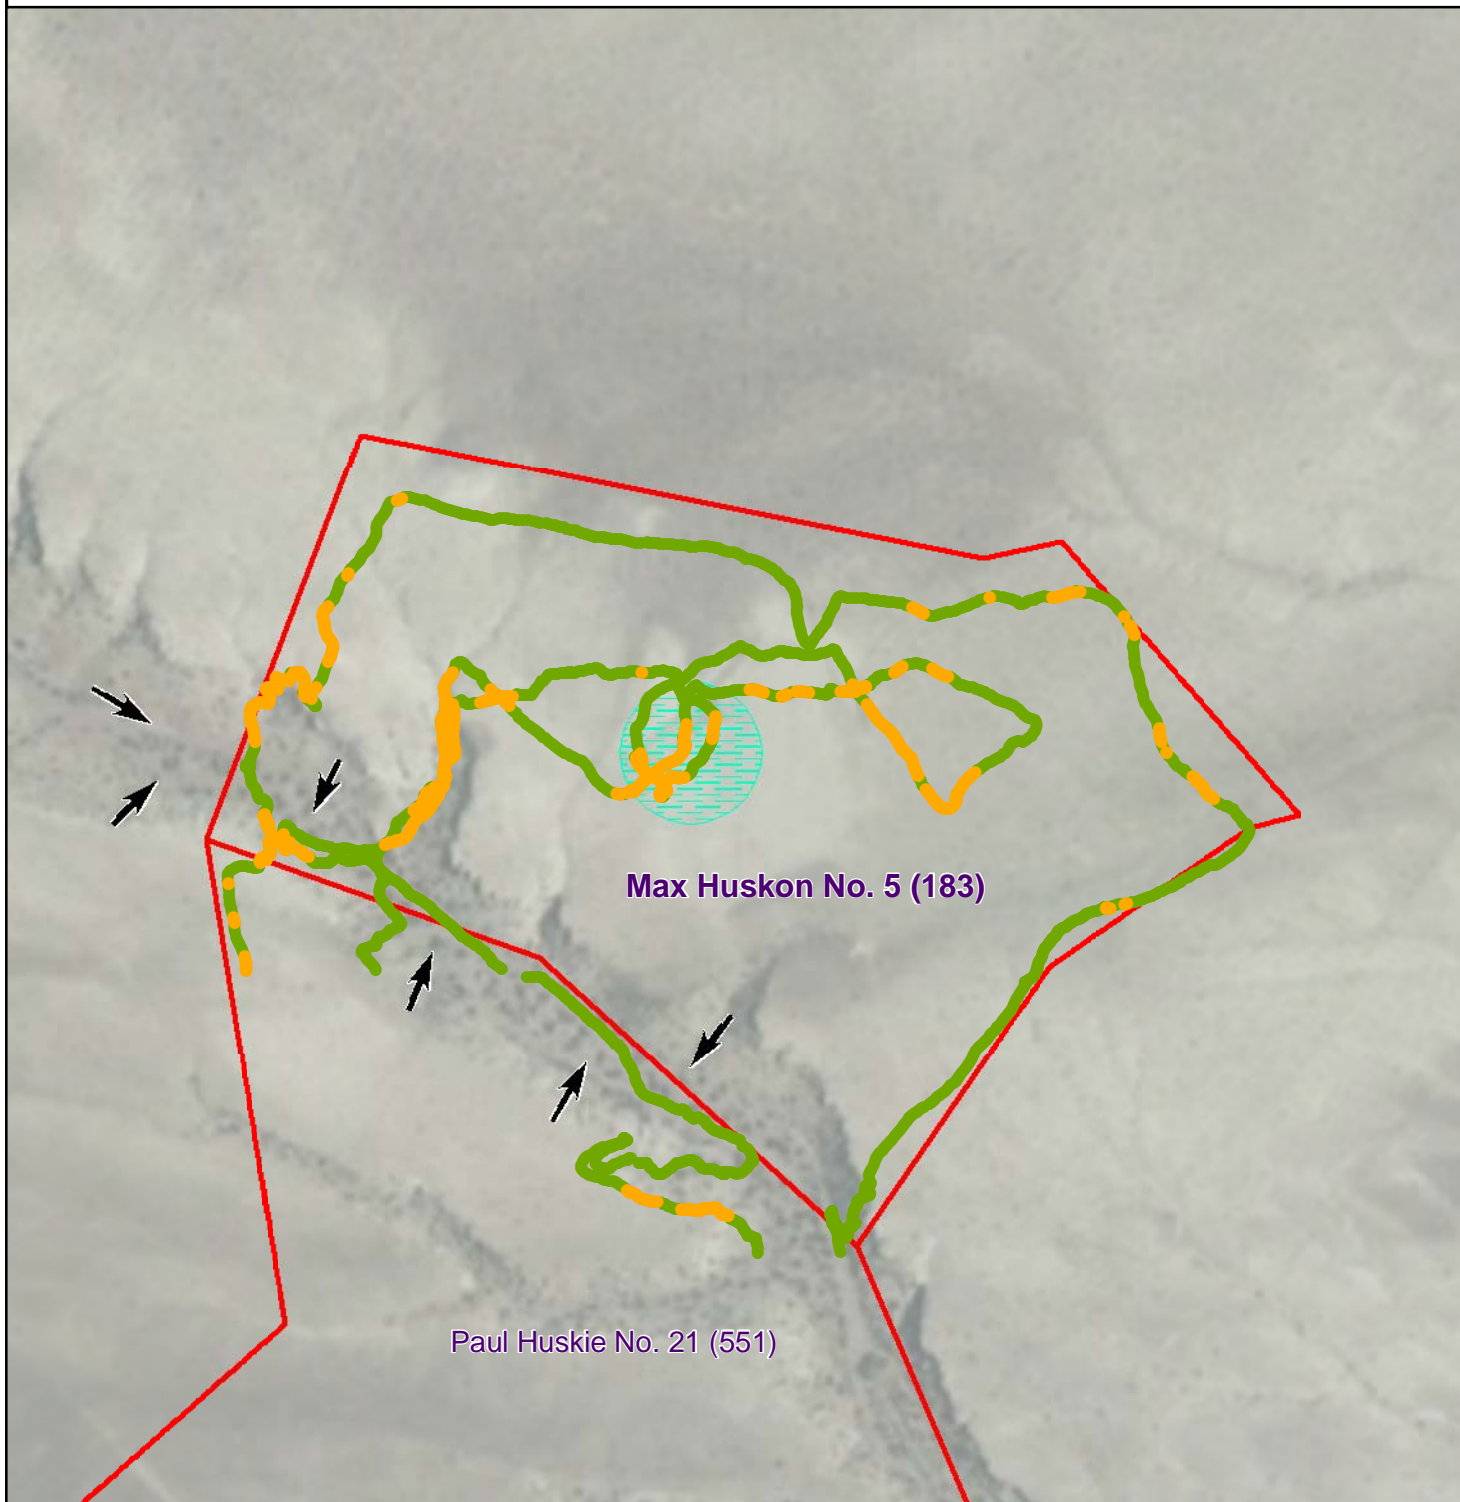
**Figure 1 - Gamma Radiation Measurements, Above Two Times Background**  
**Max Huskon No. 5 (183)**  
**Bodaway / Gap Chapter, Navajo Nation**

A total of 2,793 gamma radiation measurements were collected from the mine site, ranging from 14,754 cpm to 316,089 cpm. Measurements collected in the vicinity of the reclamation area were found at a maximum level of approximately 100,000 cpm. The measurements are represented in Figures 1 and 2.

Average background 18,938 cpm

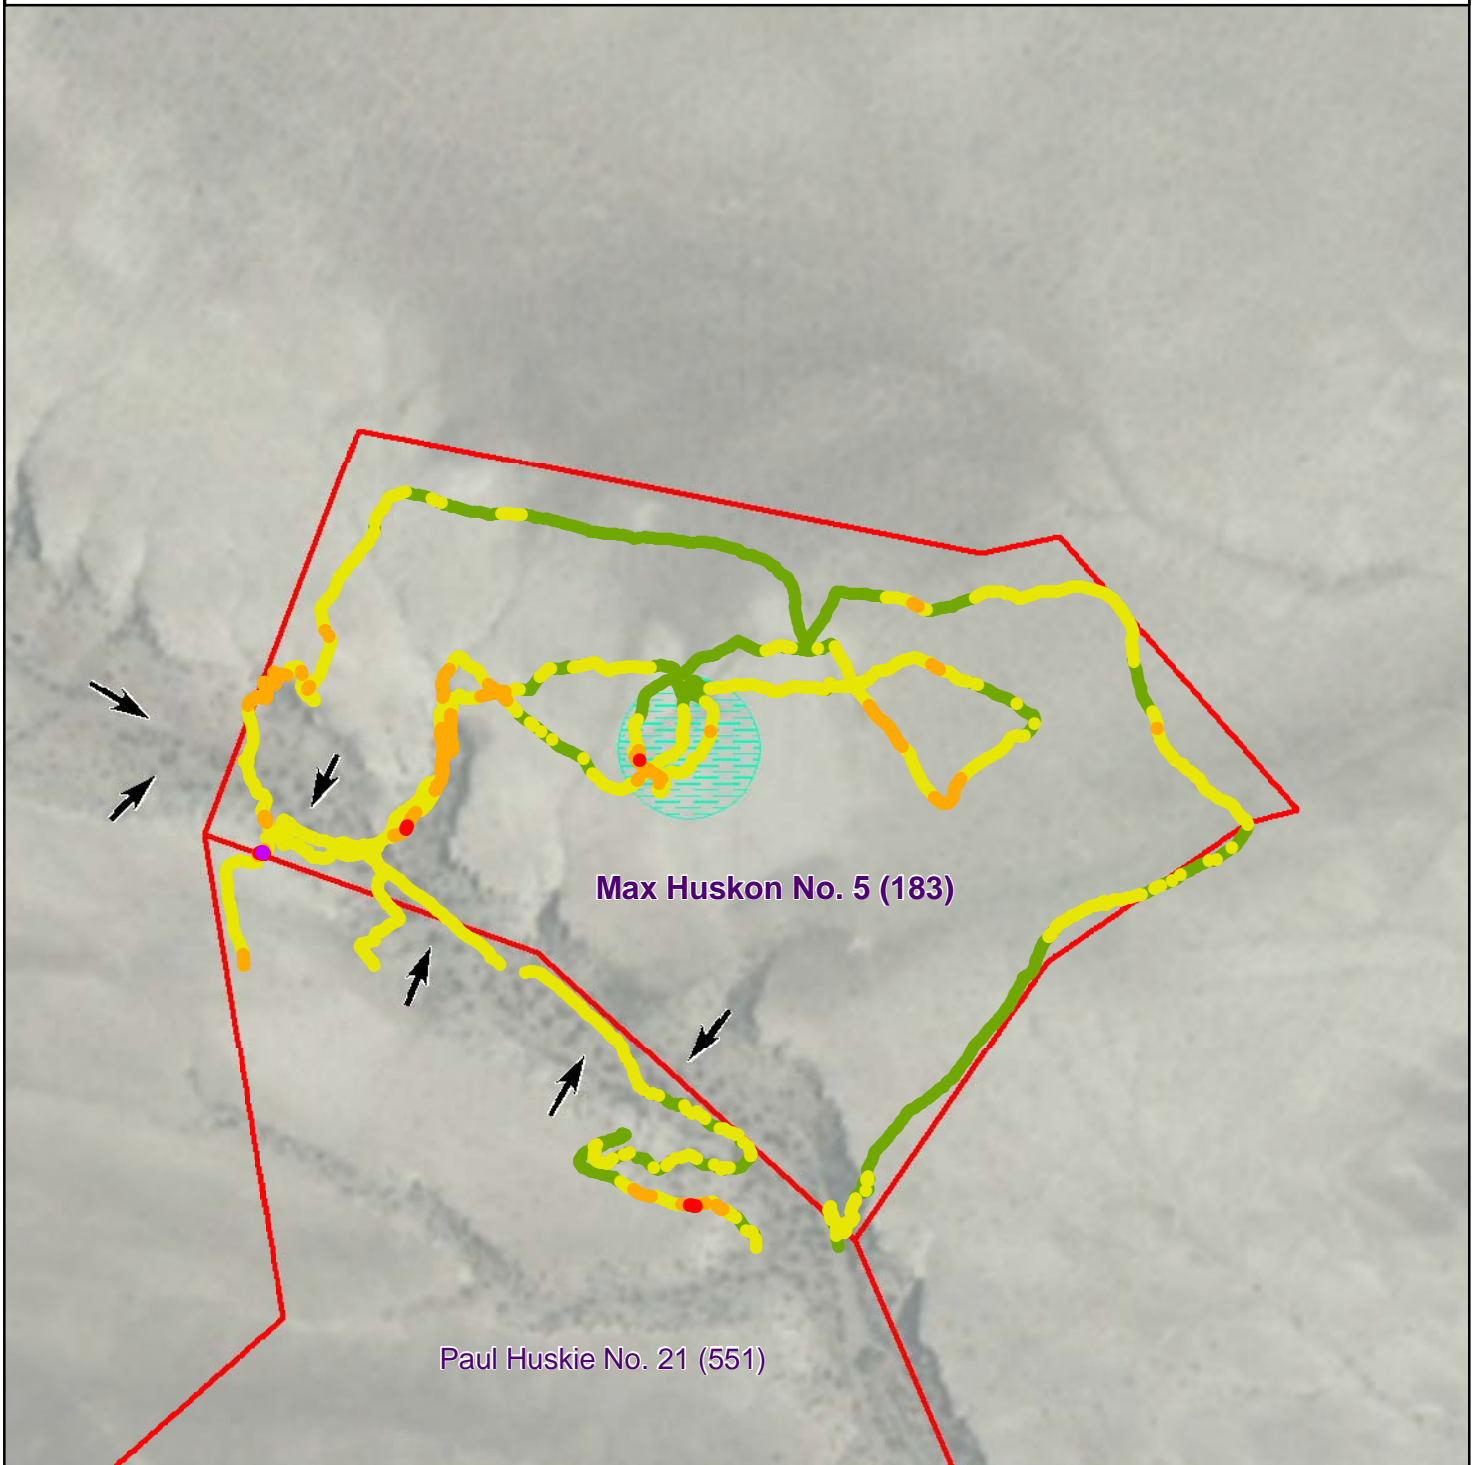
**Figure 2 - Gamma Radiation Measurements**  
**Max Huskon No. 5 (183)**  
**Bodaway / Gap Chapter, Navajo Nation**

Measured as counts per minute (cpm) Average background 18,938 cpm
